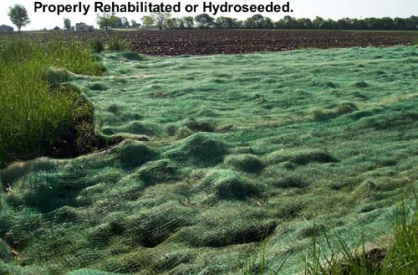
**Quality Costs Less. This was an
Emergency Response Site that was not
Properly Rehabilitated or Hydroseeded.**
